Repair, Reinstate, Restore

PROJECT PROFILE

Cobden House & 47 Gloucester Avenue

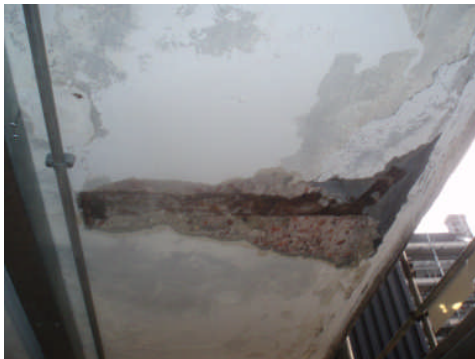
The walkways at **Cobden House** are of filler joist construction, with clinker concrete infills, rendered and painted. Here corrosion was due to water ingress from above and causing spalling on the soffit surface.

At Cobden House loose and defective concrete and render were removed. The steel filler joists were then mechanically wire brushed and primed, followed by the installation of stainless steel mesh. High build

polymer modified hand placed repair mortars were used for reinstatement. A thin cementitious filler was then applied to the soffits to cover the mapping effect caused by the removal of defective paint, followed by the application of a pigmented anti-carbonation protective coating.

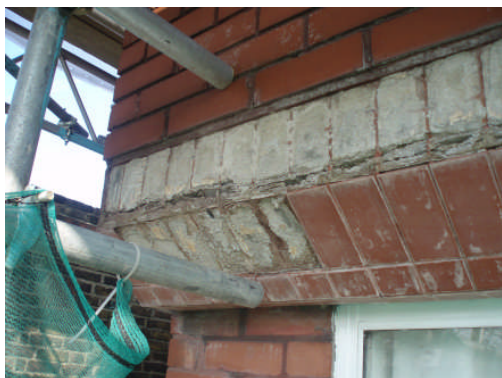
Gloucester Avenue is a tiled concrete frame building. Water ingress behind the tiles had caused the reinforcement within the concrete to corrode resulting in concrete spalling and debonding of tiles creating a hazard for pedestrians below.

At **Gloucester Avenue** traditional concrete patch and girth repairs were carried out where localised spalling had occurred. The tiles were reset with stainless steel pins drilled and resin fixed through their faces with a colour match mortar to disguise the pin head.

There was also a concern about the risk of further spalling where there were no signs of deterioration. The application of a migrating corrosion inhibitor (MCI) to the concrete to reduce this risk would have required the complete removal of the tiles. Structural Renovations were able to offer an alternative to this that saved the client both time and money.

Holes were drilled through the face of the tile at 200mm centres along the front elevation of the building and Margel Vapour Phase Release pellets were inserted. These act similarly to an MCI without the need to remove any finishes. Tiles were then repaired similarly to where the steel pins were installed.
