Repair, Reinstate, Restore

PROJECT PROFILE

King Solomon Academy

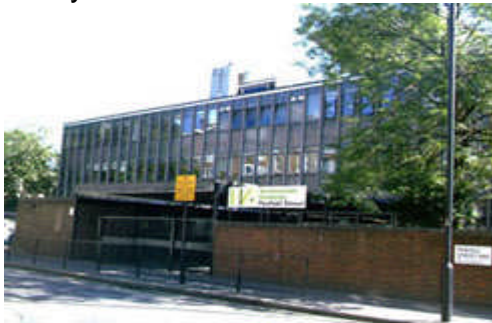
The uncoated precast concrete mullions to the Teaching Block were in reasonable condition for their age with the need for concrete repairs, cleaning and application of a migrating corrosion inhibitor (MCI) and clear coating to provide protection to the reinforced concrete.

This was followed by the forming of concrete repair samples in moulds using a variety of hand applied concrete mixes incorporating both OPC & white cement together with SBR in varying ratios. A number of these were then rendered with a variety of sand/cement mixes for a thickness of 3mm and then prepared to expose the aggregate to simulate 50 years of weathering

The works to the façade were accessed from a combination of cherry pickers and scissor lifts to allow for a full visual inspection, hammer test, cover meter survey and carbonation depth testing. The mullions were cleaned followed by the concrete repair and render treatment that were hand rubbed in places to achieve a matching finish. This then followed by the application of the MCI and clear coating.

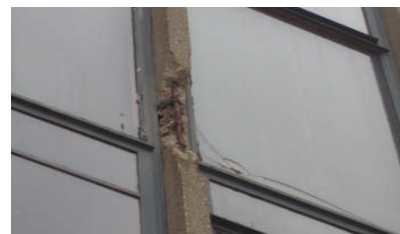
Once the glazing had been replaced and the existing frames prepared and painted the building was back to the condition that reflected its grade II* listing.
