Repair, Reinstate, Restore

PROJECT PROFILE

Leisure Centre Basement Swimming Pool

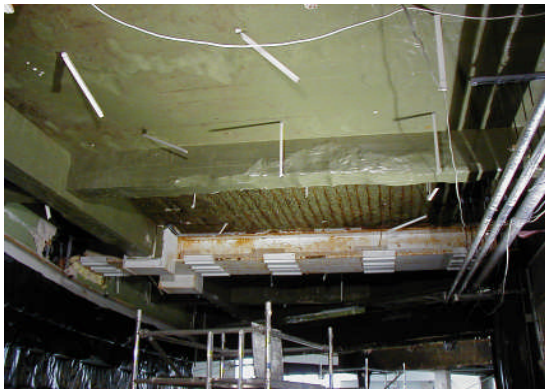
An inspection of the concrete soffit above the suspended ceiling of a leisure centre swimming pool housed in the basement of the converted building found severe corrosion of the reinforcement and extensive spalling of the concrete. In addition the structural steelwork installed some years ago during the conversion of the building had corroded with the resultant rust debonding in sheets.

The severity of concrete degradation resulted in the need to install major propping prior to removal of defective concrete. Over 1200 sacrificial anodes in strings of 10 were then installed to the

soffit and beams to control corrosion together with monitoring anodes and boxes.

Preparation of the surfaces by open grit blasting was followed by repair using 7 tonnes of hand placed mortars and 30 tonnes of spray concrete. A cementitious fairing coat and elastomeric coating were applied to both the repaired and existing concrete to enhance protection to the structure.

The structural steelwork was also cleaned by grit blasting followed by the application of a high performance coating system.
