Repair, Reinstate, Restore

PROJECT PROFILE

Mill Hill School

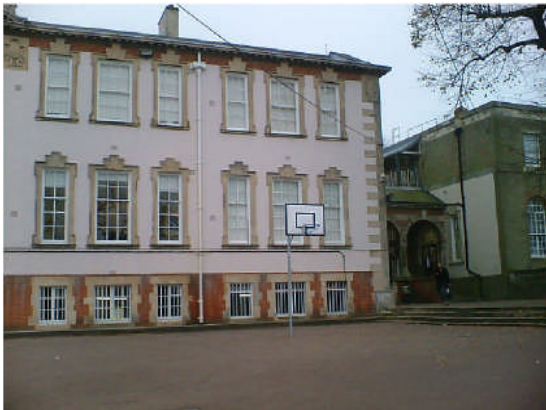
The Marnham Building at Mill Hill School was refurbished as part of a major project being carried out at the school by Mansell. The basement of the building had damp problems with the floor slab, previously painted brick walls and concrete filler joist soffit below an external pedestrian walkway. The area was required for a future teaching facility.

Following opening up and investigation, the Company was awarded a design and construct contract for the repair and strengthening of the defective filler joist steels and concrete surround. Steel joists were grit blasted and 55m of Weber Building Solutions Enforce carbon fibre reinforced plates were bonded to the underside with EP Structural Adhesive.
