Repair, Reinstate, Restore

PROJECT PROFILE

Safestore, Edgware

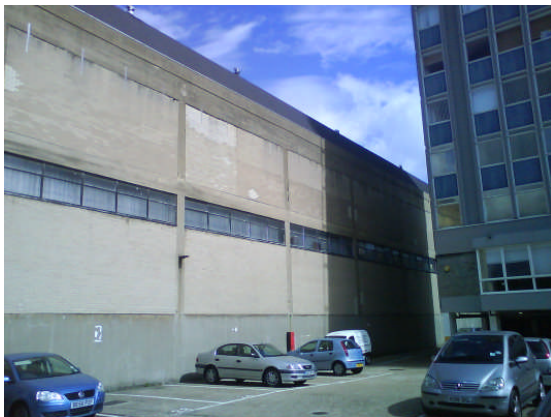
An investigation was carried out by Martech Technical Services to establish the causes and the extent of defective concrete. During this investigation it was identified that the brickwork panels were moving under light hand pressure. After further investigation it came to light that there were no ties between the outer leaf of brickwork and the inner leaf of blockwork in any of the panels.

Structural Renovations Ltd installed Helifix DryFix remedial wall ties to tie the inner and outer leaves of brickwork together as well as the outer leaf of brickwork to the concrete columns. Specially designed steel wind posts were fabricated and installed at the midpoint of the brickwork panels by our sub-contractor, Artistic Engineering Limited. These were deemed necessary due to the brickwork panels being the largest size that building regulations permit.

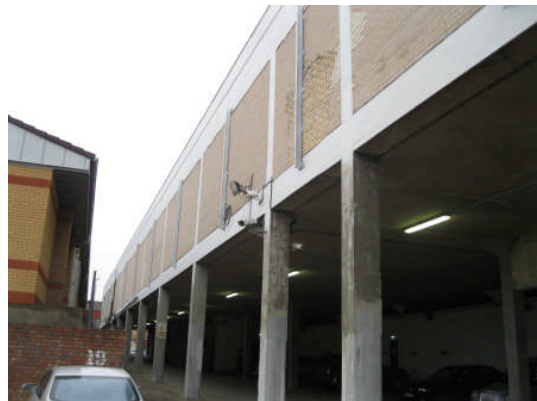
In addition to the above, the building's concrete frame was in a poor state of repair. Following the full site investigation

extensive concrete repairs were undertaken. Furthermore, the concrete frame was enhanced by the installation of Margel Vapour Phase Inhibitor pellets, a migrating corrosion inhibitor in capsule form, and the application of a pigmented anti-carbonation coating.

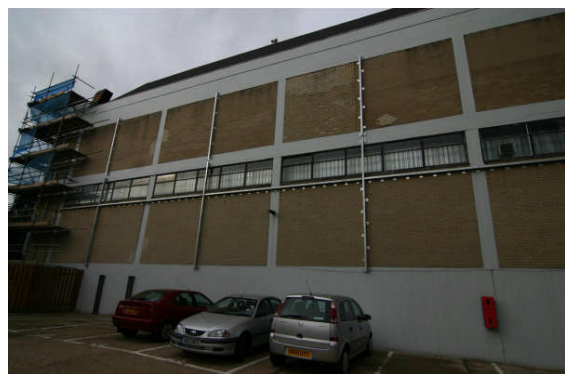
The building remained occupied throughout with the site foreman working closely with Safestore staff and customers as well as the users of adjoining properties.

Additional works were carried out which included the waterproofing of an external staircase using one of Sika Limited's flooring products and the removal of 2No. large window sets and replacement with rendered blockwork.
