Repair, Reinstate, Restore

PROJECT PROFILE

Southwark Pier Wall

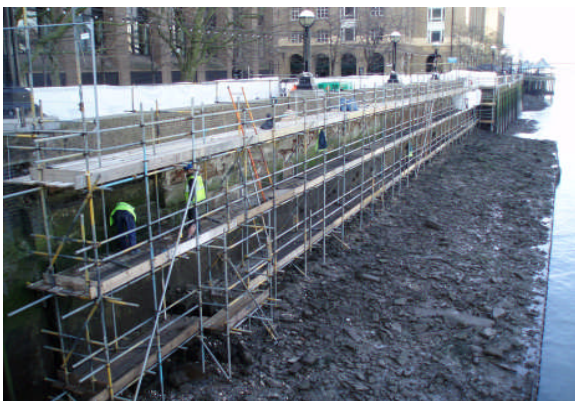
Scaffolding was progressively erected along the face of wall, founded on the riverbed and mechanically tied to the wall, with all scaffold boards tied down to prevent movement due to tidal action.

Defective render was removed by use of electric breakers to expose the old brickwork below. Eroded joints were repointed in a fast setting repointing mortar and missing bricks replaced with bricks that matched the existing. Weed killer was applied to unwanted vegetation.

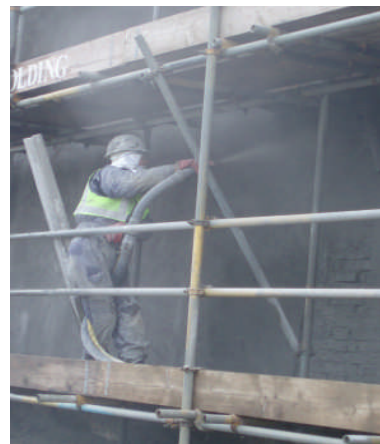
The wall was constructed from yellow stock bricks that had been protected by render in places, however due to many years of weathering by the tides the exposed areas of masonry had suffered from loss of pointing and failed brickwork.

This was followed by preparation of the surfaces by grit blasting to provide a key for the application of a spray concrete containing an alkali free accelerator and reinforced with polypropylene fibres. The finish was cut to line and trowelled whilst the excess material was cleaned from the scaffold and riverbed prior to the rising tide covering the work.
